**NISTIR 4868**

# **Interim Report: Preliminary Sitewide Survey of Reinforced Concrete Structural Deterioration at NIST**

August 1992

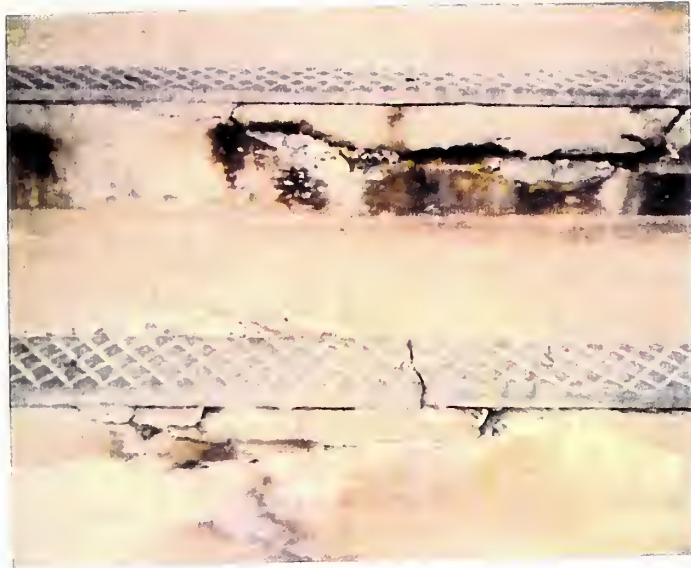
*BUILDING 205 - FRONT STAIRS*

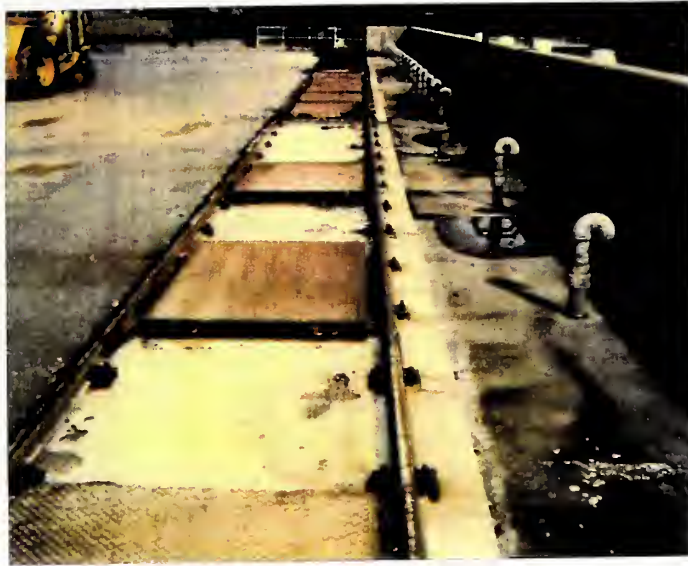
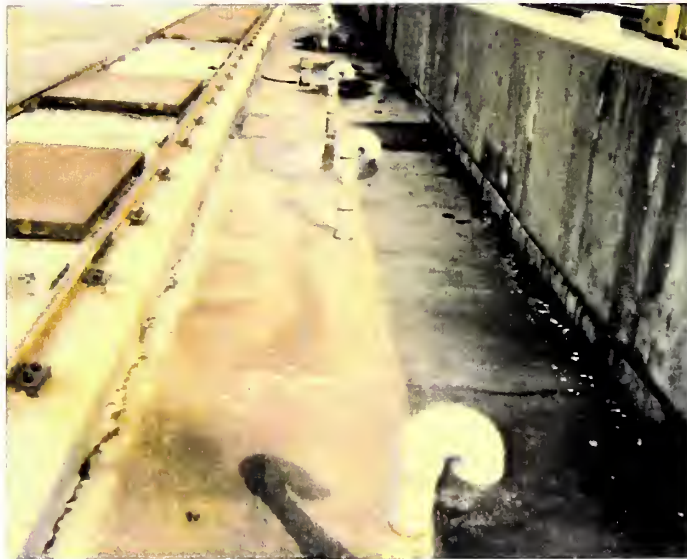
*BUILDING 206 - STORAGE BINS ROOF*

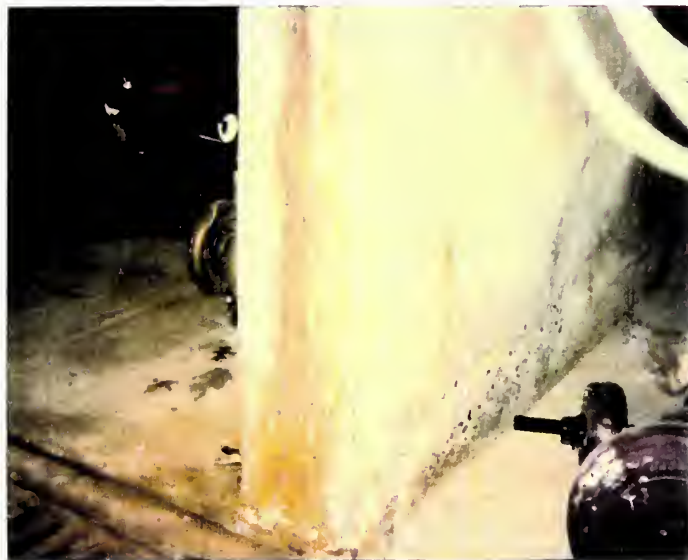
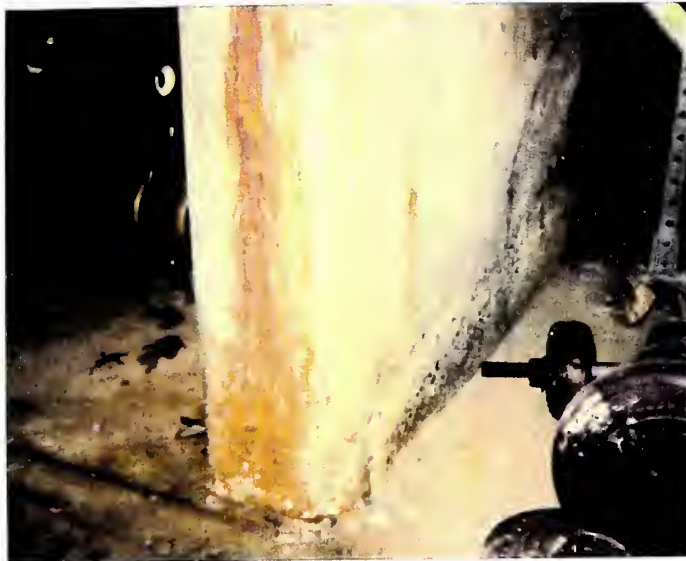
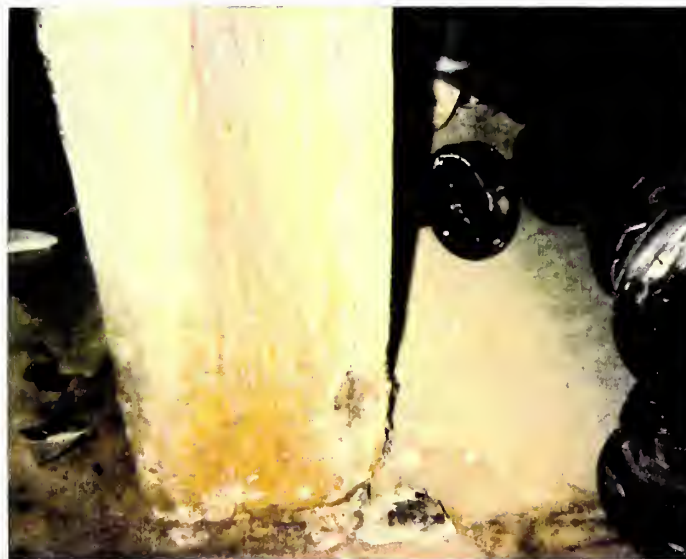
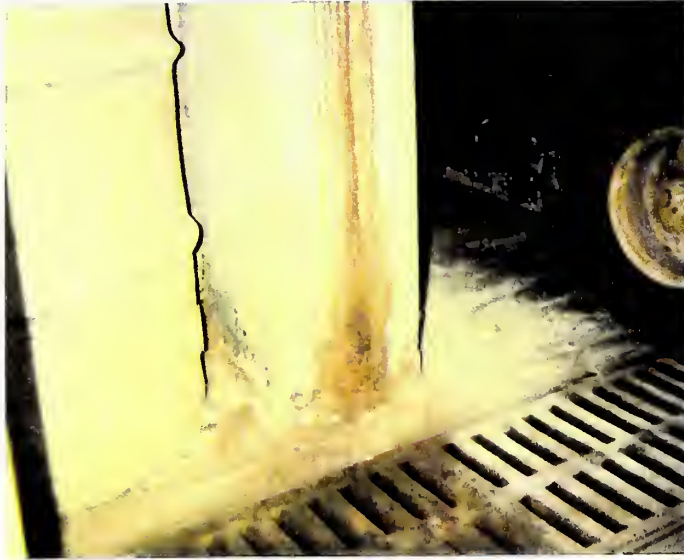
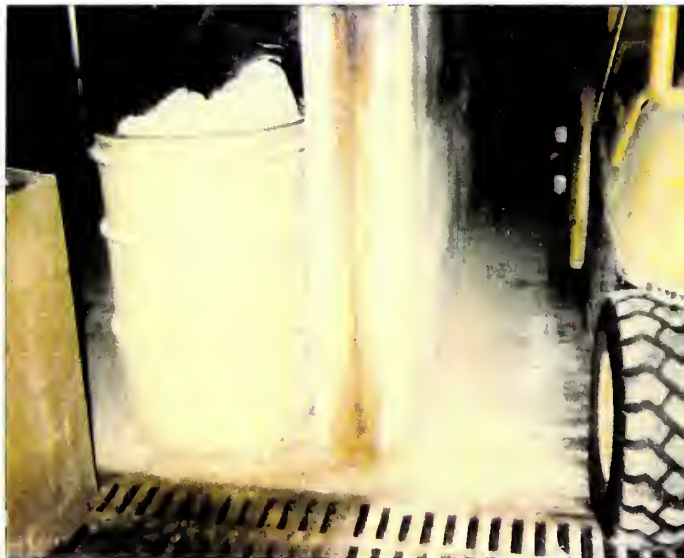
*BUILDING 206 - STORAGE BINS*

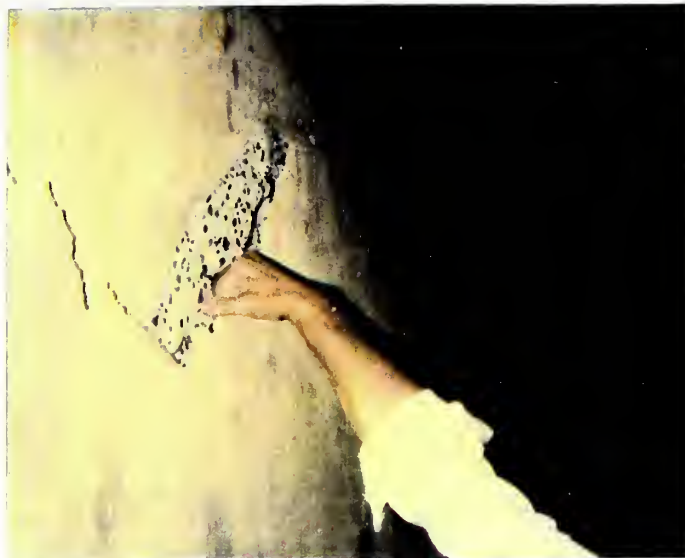
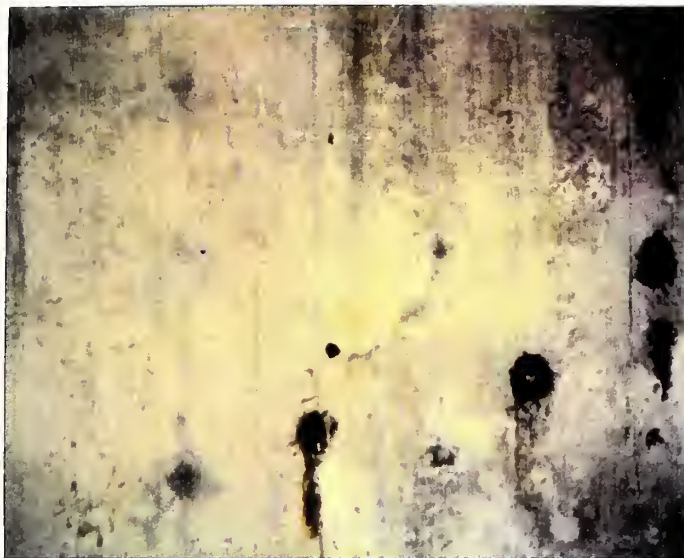
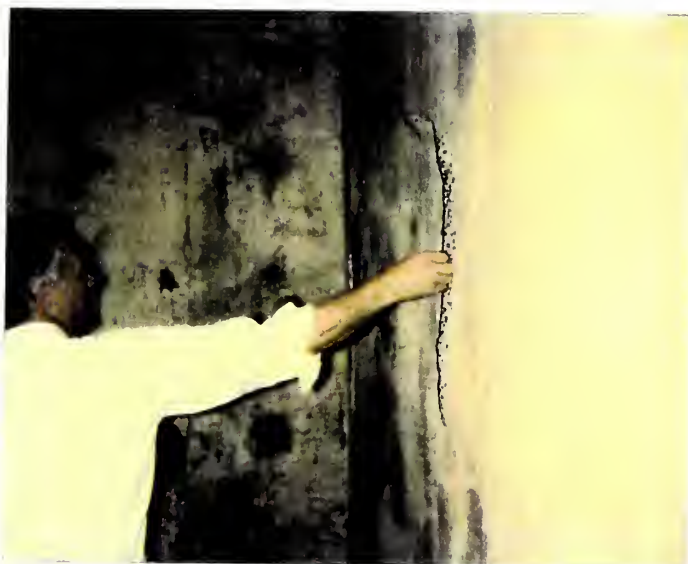
*BUILDING 206 - TOP STORAGE BINS*

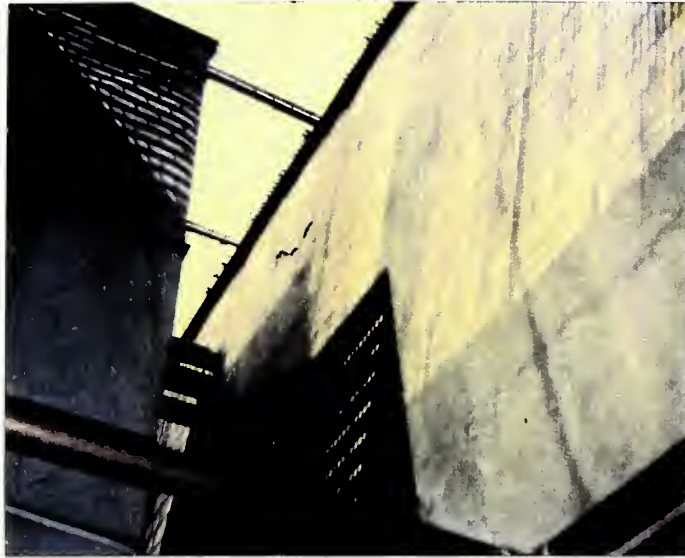
*BUILDING 230, NORTHWEST PIT*

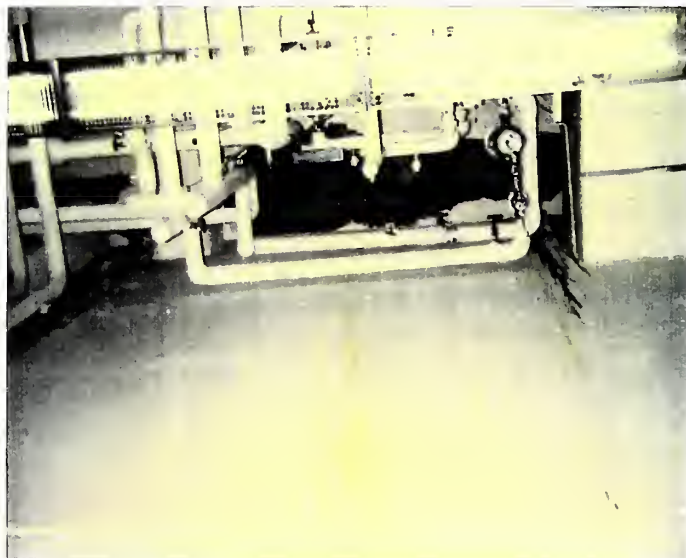
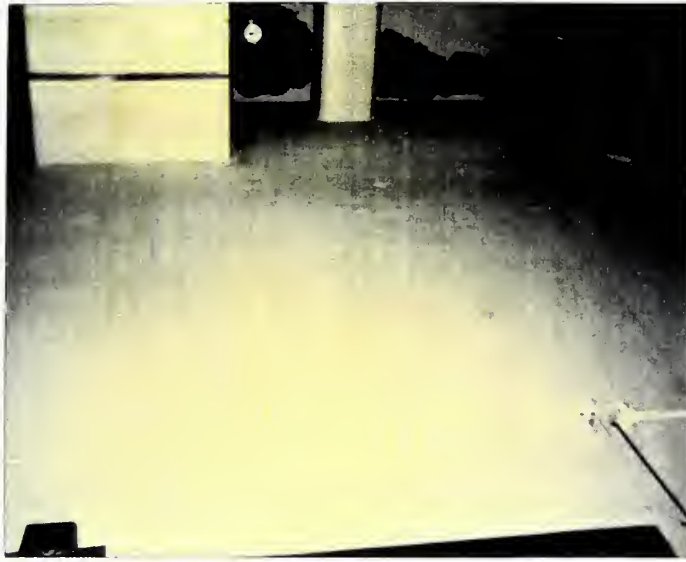
*BUILDING 233 ROOF SLAB, ROOM A121  
(AFTER REMOVAL OF DELAMINATED CONCRETE)*

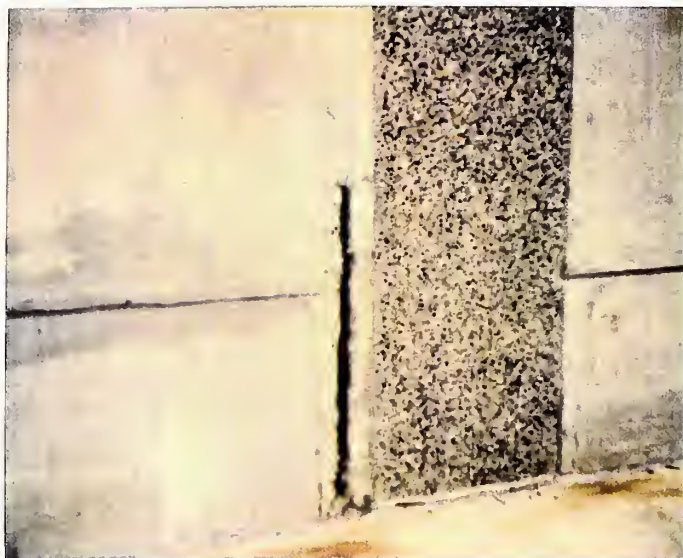
*BUILDING 235, WEST WALL*

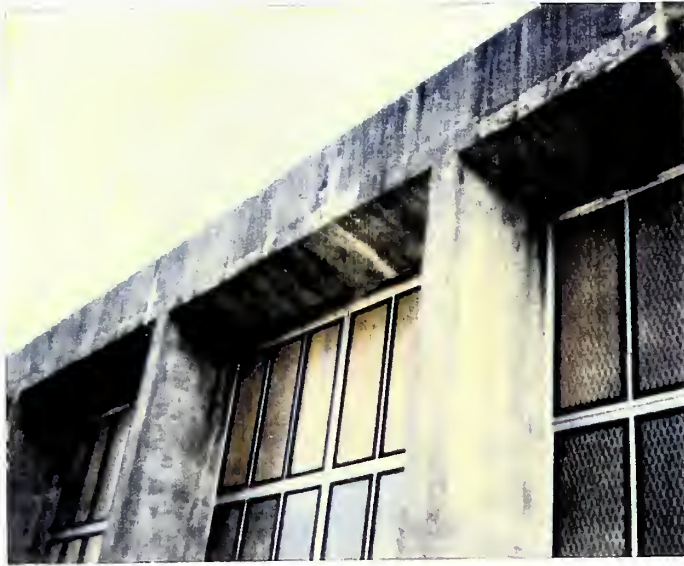
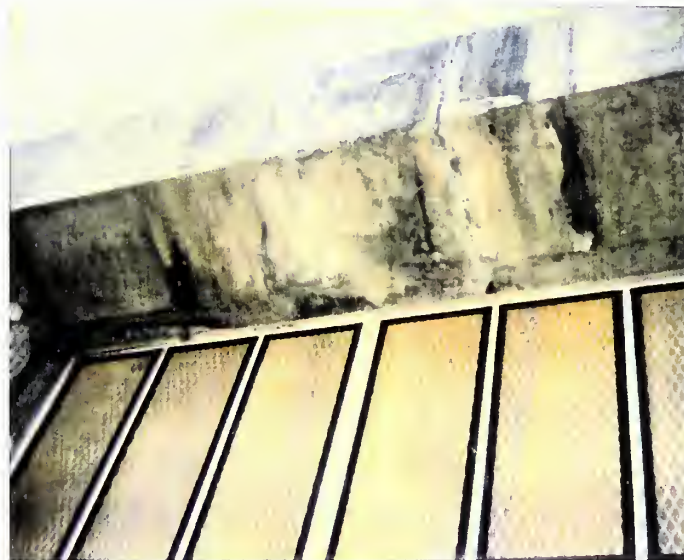
*BUILDING 236 - NORTH WALL*

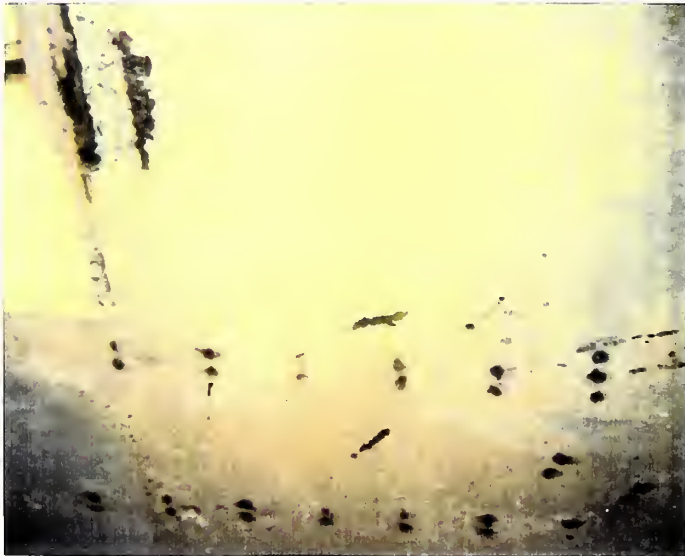
ELECTRIC MANHOLE 50: CEILING, EXPOSED REBAR/DELAMINATION AT BOTTOM  
OF ACCESS HOLE

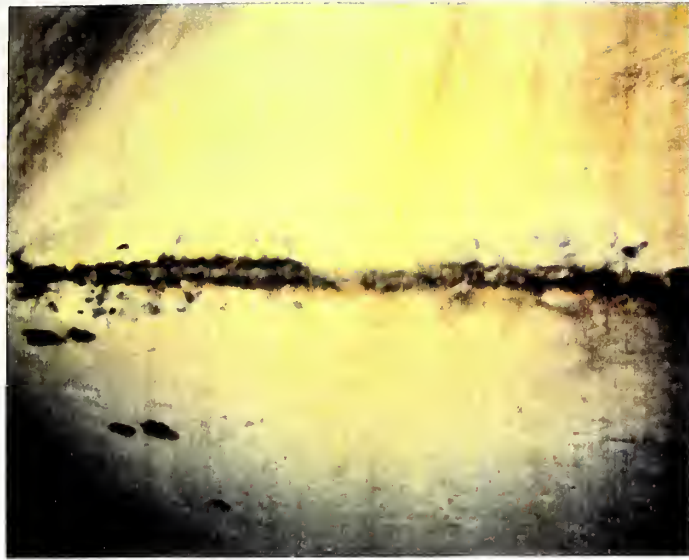
ELECTRIC MANHOLE 50: CEILING, EXPOSED REBAR/DELAMINATION AT BOTTOM  
OF ACCESS HOLE

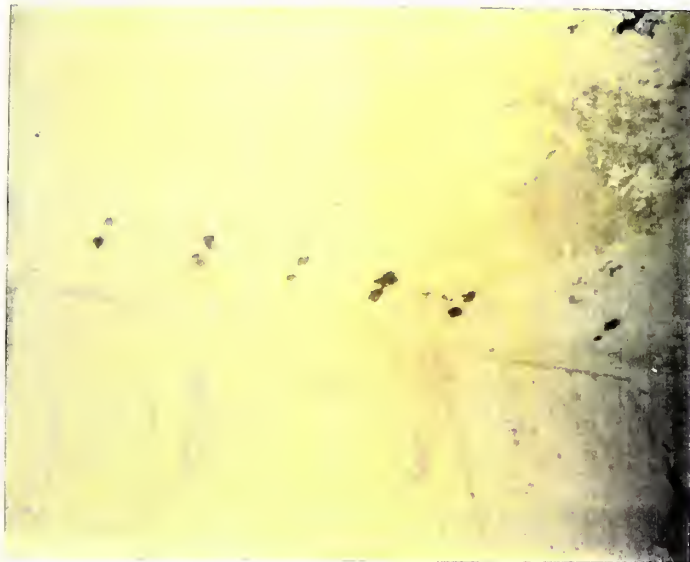
FIGURE 88

ELECTRIC MANHOLE 50: CEILING DELAMINATION

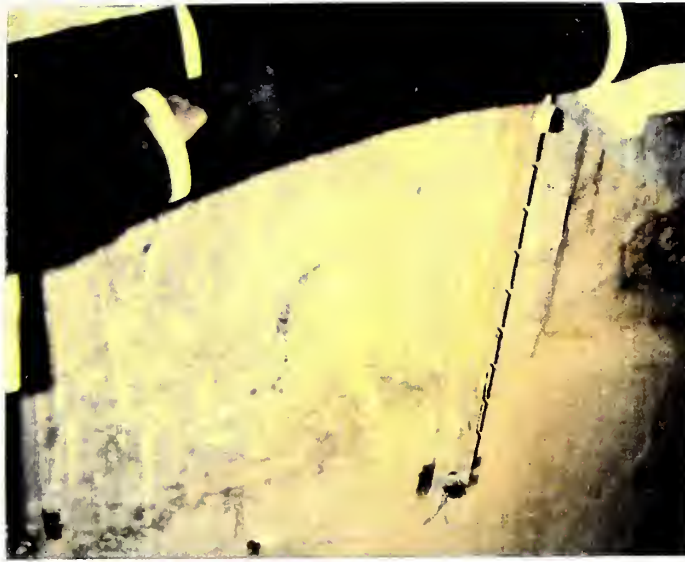
ELECTRIC MANHOLE 50: DELAMINATION ON SOUTH WALL

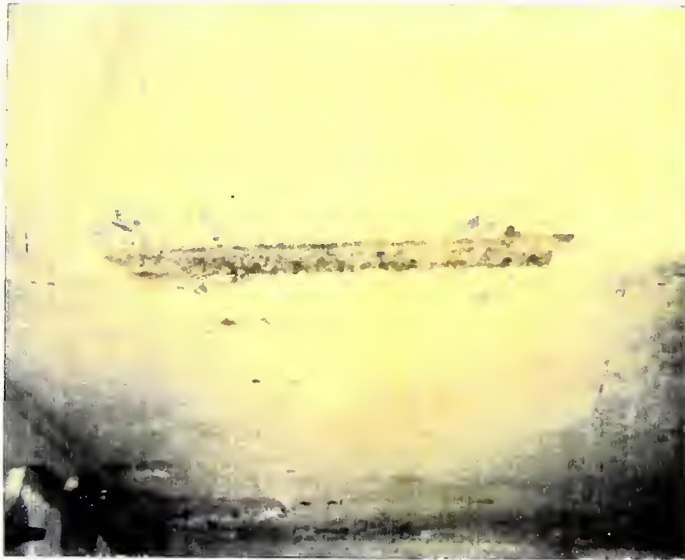
SIGNAL MANHOLE 50: CEILING, EXPOSED REBAR/DELAMINATION AT BOTTOM OF ACCESS HOLE

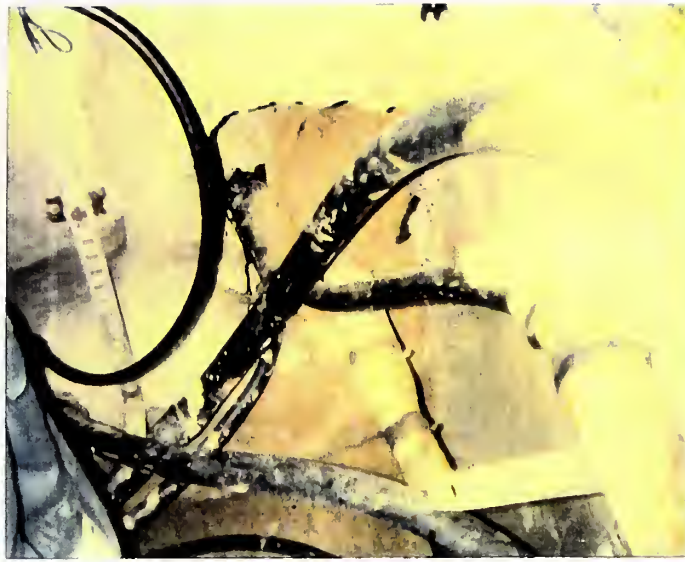
TELEPHONE MANHOLE 50: COLLAPSED BLOCKOUT ON NORTH WALL

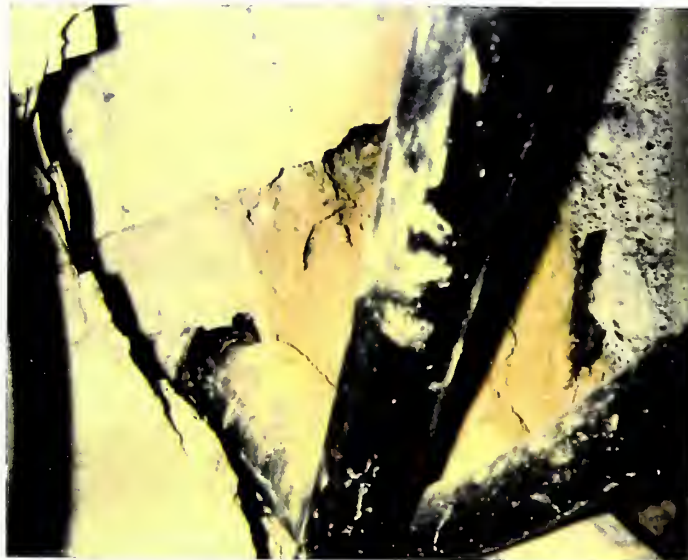
TELEPHONE MANHOLE 50: COLLAPSED BLOCKOUT ON NORTH WALL

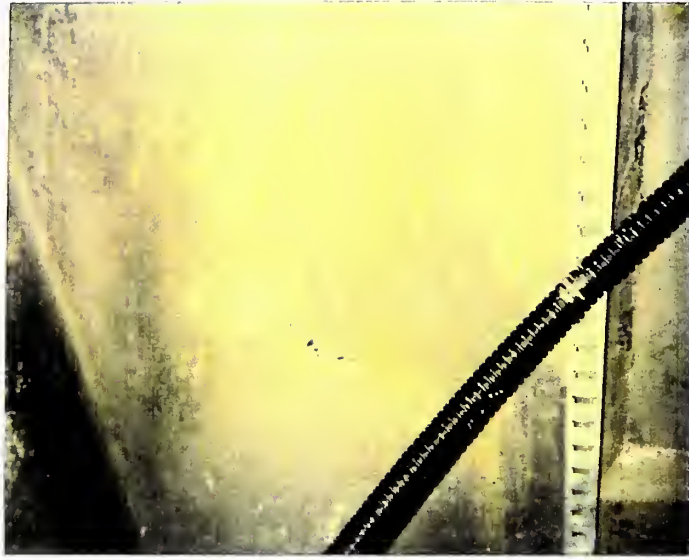
TELEPHONE MANHOLE 53: DELAMINATION ON NORTH WALL

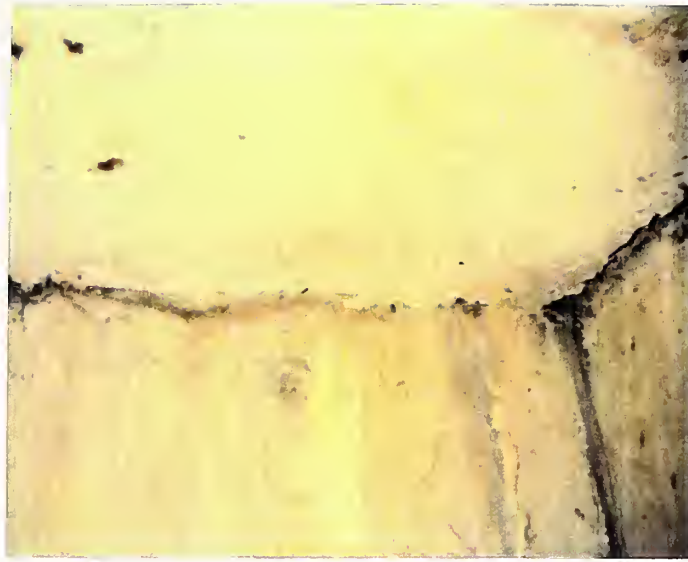
SIGNAL MANHOLE 64: DELAMINATION IN NORTH WALL (UPPER)

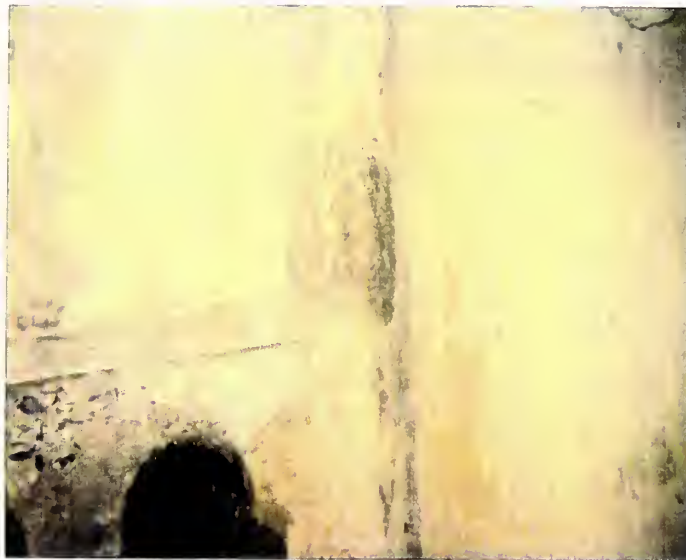
FIGURE 93

SIGNAL MANHOLE 64: DELAMINATION IN NORTH WALL (LOWER)
